**Butler
Rowland
Mays**
Architects, LLP

Troy Public Library - *Main Branch*

Architectural Building Evaluation

Dates Performed: August 27, September 12, and October 8, 2013

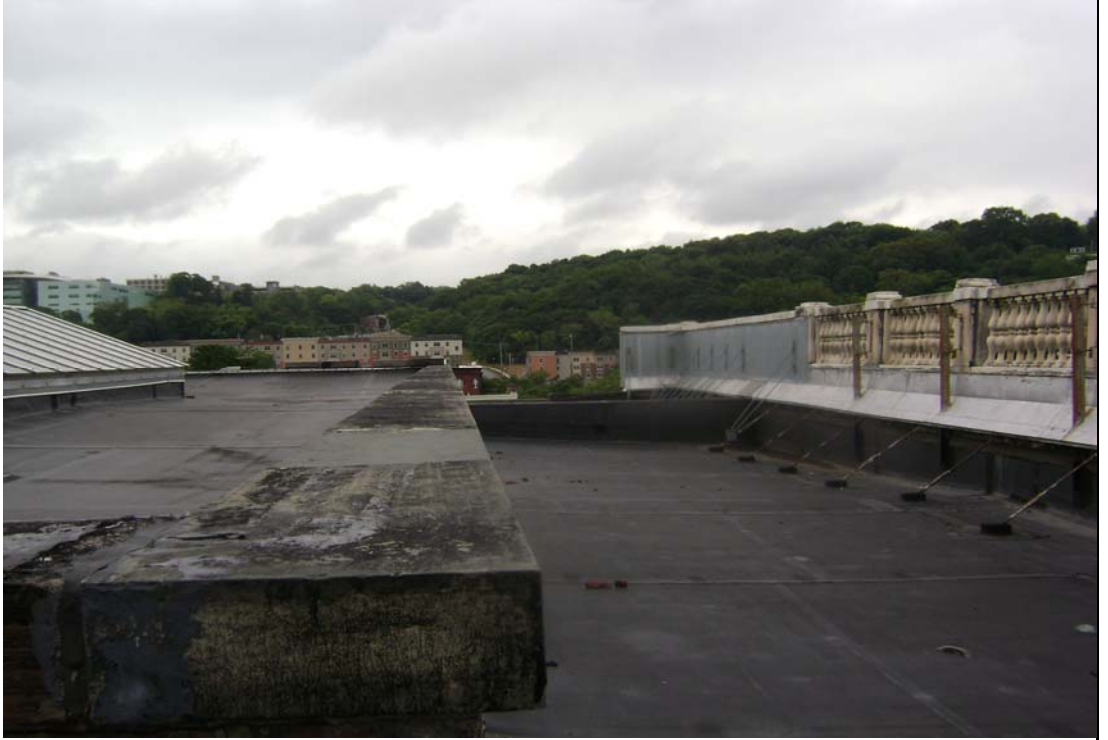
Building Element or Façade	Roof
Photo

Existing Conditions	<ul style="list-style-type: none"> • The building's roof is divided into four large areas, and two smaller roof areas. All of these membrane roofs were reputedly recently installed and are in acceptable condition from visible inspection. Areas in need of patching or repair were noted to the Library Director while on site. • There are a few membrane splits and some failed pitch pockets. • The accessible roofs do not appear to have tapered insulation beneath the membrane, and in many areas there seemed to be uneven material underfoot. It is possible that the visible membrane roof is installed over a previous roof.
Preliminary Recommendations CATEGORY 3	<ul style="list-style-type: none"> • At least twice a year, the accessible roofs should be walked and visually inspected for areas of damage, wear, or age. During these inspections roof drains should be cleared of any debris, if present; and any miscellaneous materials should be removed. • A qualified roofing contractor should visit the building at least once a year to review the roofs and perform patching and repairs, as well as any other required maintenance.

Additional Investigation	Core samples at each roof area should be taken for testing to determine if a second roof exists, and if there are any hazardous materials that will need to be abated when the roofs are removed and replaced in the future.
Notes

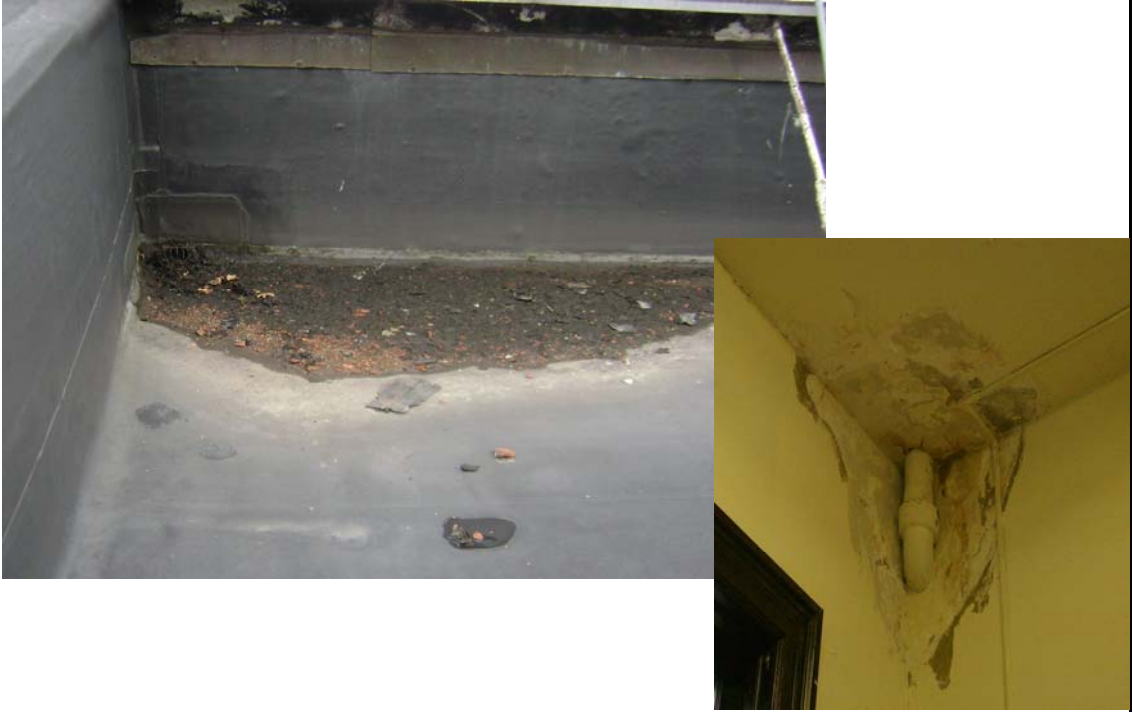
Building Element or Façade	Roof - Drains
Photo

Existing Conditions	<ul style="list-style-type: none"> • The roof leaders that take excess water away from the main roofs and the Reading Room roof are unprotected openings in the membrane roof. Around these openings are large quantities of debris - mostly brick and mortar material that is washing out of the parapet walls. • At the interior of the building there is evidence of serious moisture infiltration at the ceilings of the Teen and Reading Rooms. This damage may be the result of water ponding at the constricted roof leaders, or from condensation occurring on the leaders as they pass through conditioned spaces. In areas where the original metal vents are still present at the walls, there is little to no ceiling/wall damage, which suggests condensation is part of the issue.
Preliminary Recommendations CATEGORY 3	<ul style="list-style-type: none"> • Strainers should be placed on all of the roof leaders to prevent unwanted material from clogging the drain. • Once installed, these strainers should be cleaned out at least twice year to prevent clogging and ponding. Depending on the nature of any future capital improvement project, it may be possible to expose the piping and either create a different enclosure or insulate the piping to reduce the possibility of condensation forming on the piping.

Additional Investigation	The source of the moisture infiltration at the ceilings should be explored in more detail at the roof level and in the cavity spaces between the finished ceilings and the roofs to prevent further damage to the plaster ceilings, moldings and walls.
Notes	
Building Element or Façade	Roof - Skylights

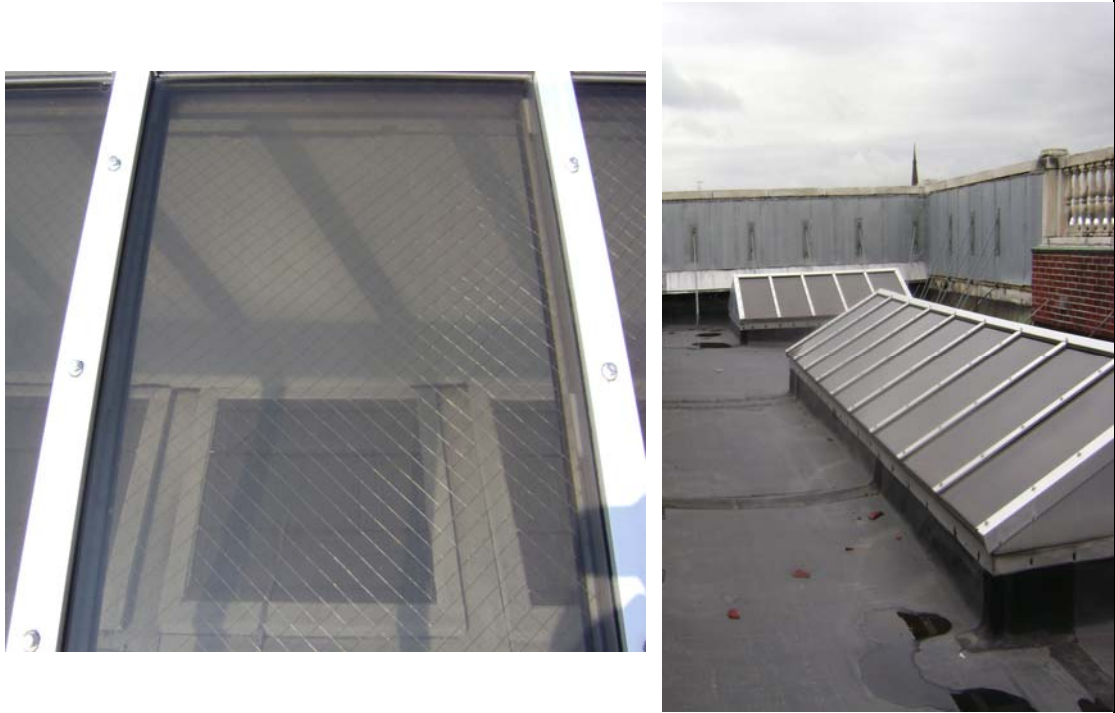
Existing Conditions	<ul style="list-style-type: none"> • The three skylights at the west portion of the building, as well as the large skylight over the Reading Room appear to be in good, water tight condition. Reputedly these four units were repaired during the roof replacement project in the early 2000's. • It appears that gaskets on the interior side of the skylight mullions are beginning to fail. Some gaskets can be observed hanging loose from the mullions. • The wired glazing in these skylights does not appear to be the type of glass required under current building codes.
Preliminary Recommendations CATEGORY 2	<ul style="list-style-type: none"> • As part of the mechanical improvements project, the existing glazed panes should be replaced with insulated units to reduce heat loss.
Additional Investigation	<p>The exact age of the skylight units is not known, however, based upon visual inspection and the ANSI label on the glazing, hazardous materials testing is suggested for the gaskets, sealants, caulks and etc. Additional building code and glazing material research will be needed to determine a suitable glass type that meets current building code requirements.</p>

Notes	<p>When improvements are made to the skylight, the laylight panels should be cleaned to enhance the quantity and quality of daylight in the interior spaces.</p>

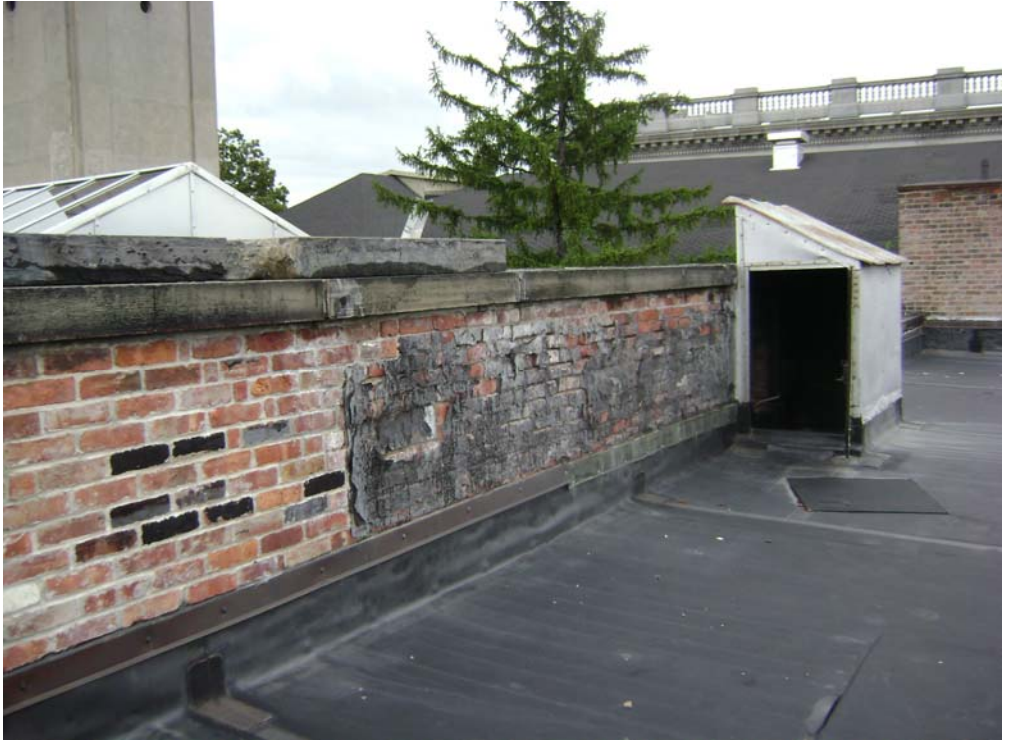
Building Element or Façade	Roof - Parapet Walls (North & East Facades and Reading Room)
Photo

Existing Conditions	<ul style="list-style-type: none"> • Many areas of the brick parapet walls are severely deteriorated, with several areas being beyond the point of simply repointing the mortar joints. • The east and north walls, as well as the central roof above the Reading Room, have bluestone copings. Age and atmospheric conditions have caused these coping stones to delaminate in many locations and their associated mortar beds and head joints are severely deteriorated allowing moisture into the wall cavities, which contributes to the brick wall damage.
Preliminary Recommendations CATEGORY 1	<ul style="list-style-type: none"> • The bluestone copings should be removed and reset with new mortar beds, anchorage and flashings. Some stones that are severely delaminated will need to be replaced with new stone. • Many areas of the brick parapet walls will need to be rebuilt entirely. This rebuilding/repair of the brick masonry will need to be addressed as part of a building-wide masonry restoration project.

Additional Investigation	The parapet walls along the Reading Room roof have an residual asphaltic material remaining from a previous roof system. This material should be tested for potential hazardous materials.
Notes

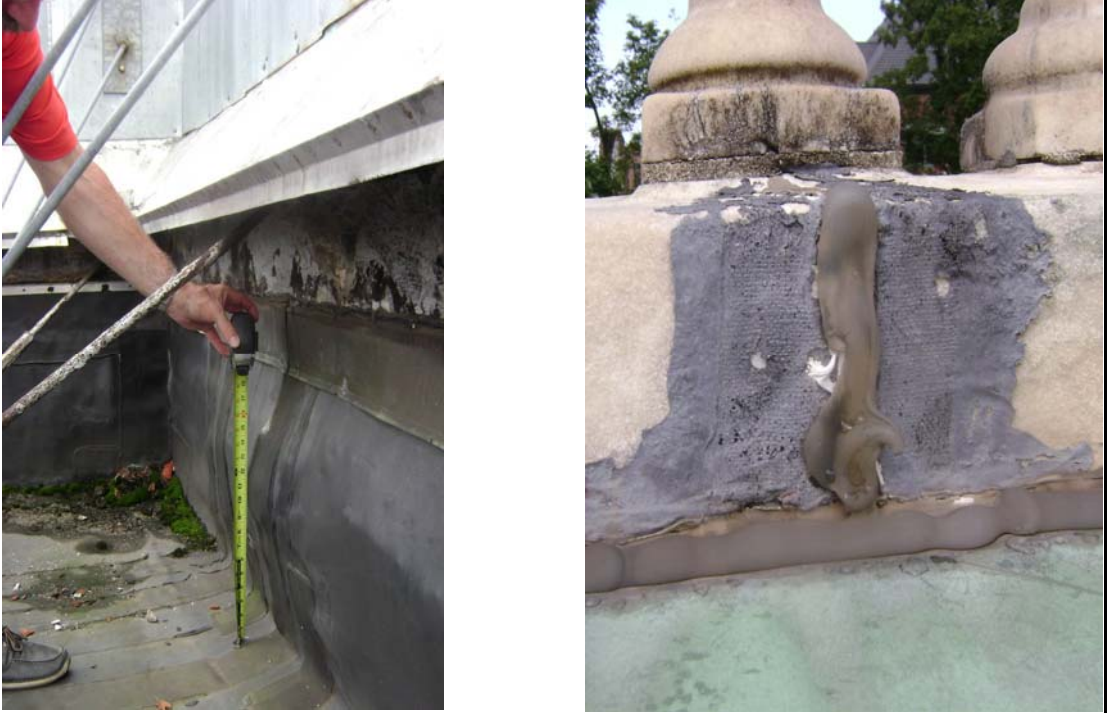
Building Element or Façade	Roof - Marble Veneer Parapet Walls (West & South Facades)	
Photo

Existing Conditions	<ul style="list-style-type: none"> At the south and west exterior walls the roof membrane is run vertically up the parapet walls which are a brick masonry system supporting marble ashlar panels, marble piers and balustrade ornamentation. The vertical installation of the membrane conceals the condition the brick parapet walls. It appears that, in many areas, the brick has spalled and deteriorated and is displacing the membrane. This is likely the result of moisture infiltration, as the mortar beds and joints of the marble cap stones are severely deteriorated, and many joints have been repaired with inappropriate materials. The marble balustrade sections are also quite deteriorated and some are becoming displaced. (**See Notes below.) 	
Preliminary Recommendations CATEGORY 1	<ul style="list-style-type: none"> The marble cap stones should be set in new mortar beds and proper joint material, either mortar or sealant, should be applied to prevent further moisture infiltration. Additionally, the coping stones and other marble ornamentation and cladding of the building will need to be included in a building-wide masonry restoration project as essentially all areas are in need of repointing.

Additional Investigation	<p>A qualified roofer should be contacted to remove (and later reinstall) selected portions of the existing roof membrane to identify the extent of moisture infiltration and brick deterioration that is occurring at these parapet walls. Also, a section of copper flashing at the north-west corner should be removed to help gain a more complete understanding of how the large, projecting marble cornice stones are anchored to the building walls.</p>	
Notes	<p>**The removal of the marble balustrade sections has been recommended separately from this report due to the safety concerns stemming from the displacement of certain sections. This work was isolated and recommended outside of this report in order to expedite the removals.</p>

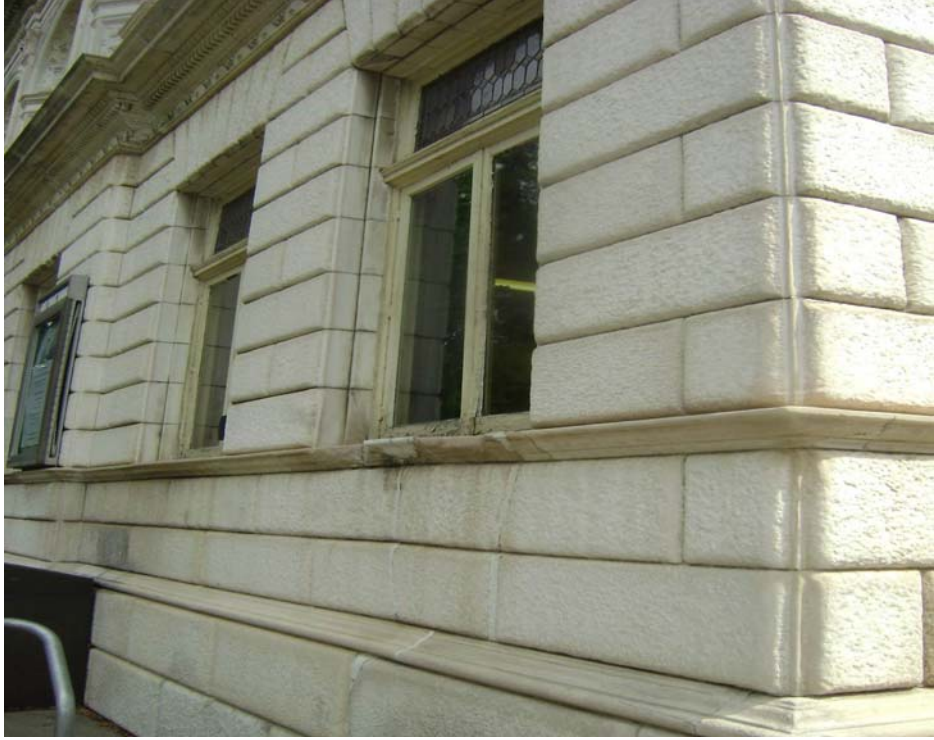
Building Element or Façade	Masonry Walls - South and West Facades
Photo

Existing Conditions	<ul style="list-style-type: none"> • The exterior walls of the building are brick masonry construction with decorative marble veneers, elaborate cornices and details. The walls featuring the marble ornamentation show severe atmospheric staining and deterioration due to exposure as well as moisture infiltration. Overall, most sealant joints are debonded and weathered, and the mortar joints are weathered, cracked or missing entirely.
Preliminary Recommendations CATEGORY 1	<ul style="list-style-type: none"> • A comprehensive masonry cleaning should be performed following the Department of the Interior's Preservation Briefs as part of a thorough examination of the masonry exterior to identify areas of deterioration and water infiltration. • In addition, the marble panels should be repointed and fastened back to the brick masonry with restoration anchors. The smaller detailed components of the cornice (dentils, brackets, etc) should be sounded for potential failures.

Additional Investigation	Based upon the size and elaborate detailing, the marble cornice components are considered irreplaceable based upon cost and availability of material. A thorough detailed evaluation of the material is warranted to determine the most effective cleaning, stabilizing, and preventative conservation options.
Notes	Regular routine maintenance of the marble and brick walls should be maintained to prevent this level of deterioration and required maintenance from occurring in the future.

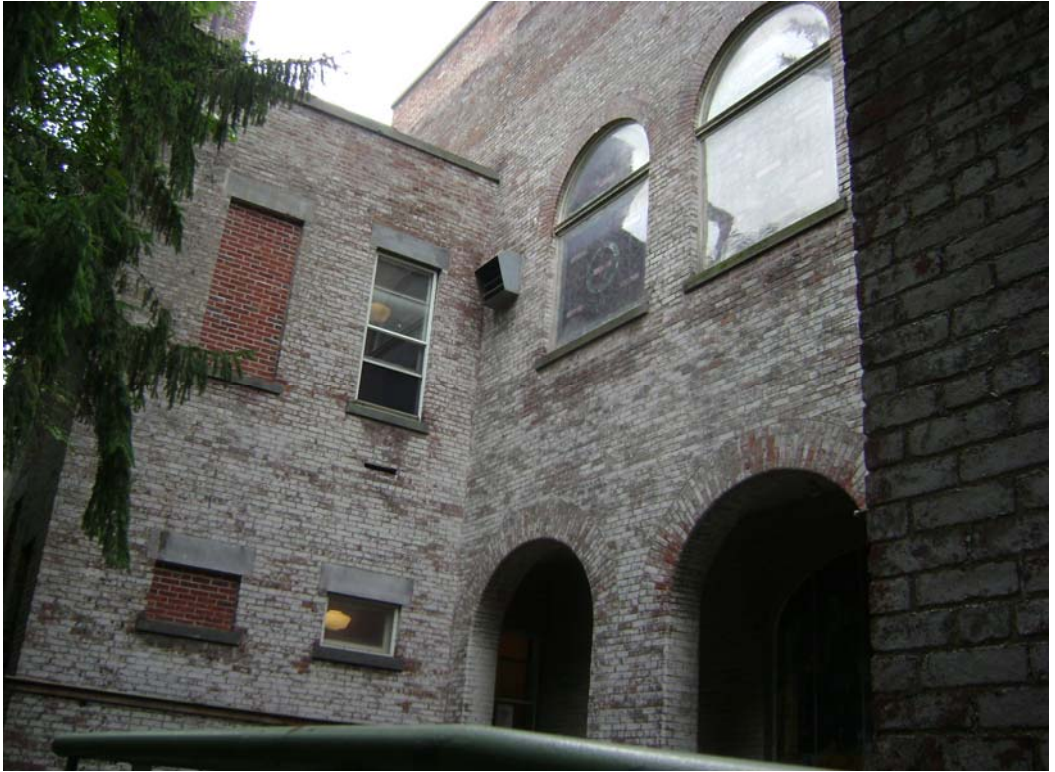
Building Element or Façade	Masonry Walls - North and East Facades
Photo

Existing Conditions	<ul style="list-style-type: none"> • The North and East faces (non-public) are typical brick masonry bearing walls, it appears that these walls have been routinely painted, however at this time most of the paint has worn off to due exposure. It is typical of the time period that secondary building faces would be constructed with a lower quality of brick which would need to be routinely painted to maintain its structural integrity and moisture resistance.
Preliminary Recommendations CATEGORY 1	<ul style="list-style-type: none"> • Although portions of the walls have been repointed as needed, a thorough review of these facades is warranted to identify all areas in need of masonry repair and repointing. • In addition to the described maintenance work, these facades should be cleaned and painted to reduce moisture infiltration and preserve the structural integrity of the brick.

Additional Investigation	
Notes	Regular, routine maintenance of the paint finish on brick walls should be performed to prevent this level of deterioration and prevent larger scale masonry deterioration from recurring in the future.

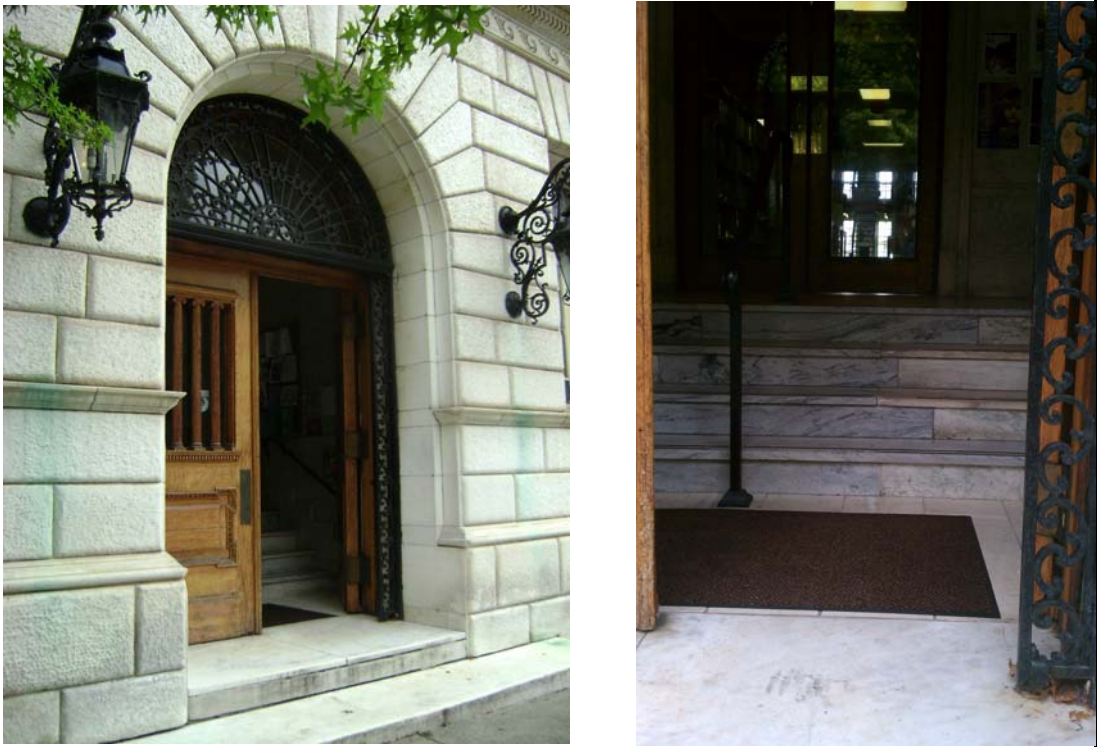
Building Element or Façade	Main Entry - West
Photo

Existing Conditions	<ul style="list-style-type: none"> • The main entrance that faces Second Street features the original marble steps as well as the wrought-iron and carved wood doors. The marble treads are showing significant wear due to use and exposure. • Once inside the paired doors, there are four additional risers which bring you to the Main Level of the building. These stairs are also marble, however textured strips have been applied to increase traction and a metal handrail has been installed at the center of the stairs for improved accessibility.
Preliminary Recommendations	<ul style="list-style-type: none"> • The exterior doors should receive regular polyurethane treatments to preserve the wood.
CATEGORY 2	
Additional Investigation	Investigate new hardware for the exterior doors to improve efficiency of operation.
Notes	<p>Although the copper wall sconces appear to have been painted, it appears that prior to the painting, the oxidation process stained the marble walls and stairs.</p> <p>The ornate sconces appear to be historic based on the detailing and materials, these fixtures should be repaired and restored as they can not be replaced. Historic preservation standards would consider these light fixtures important contributing elements to the building's aesthetic.</p>

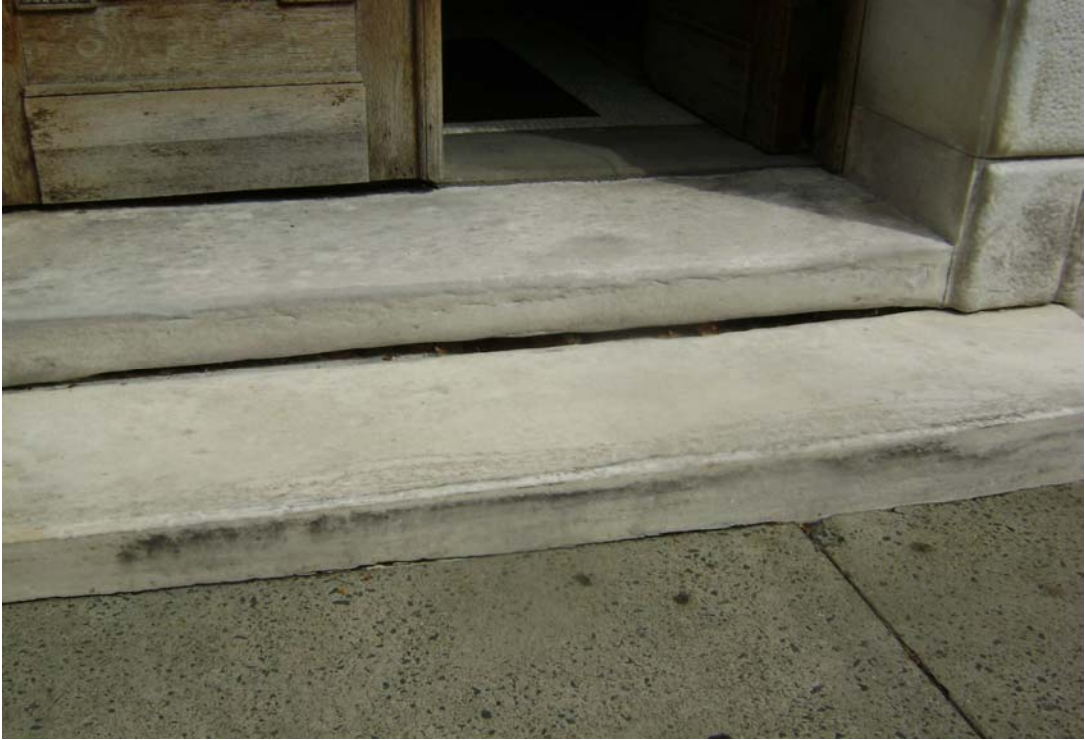
Building Element or Façade	Main Entry - South
Photo

Existing Conditions	<ul style="list-style-type: none"> The main entrance that faces south also features the original marble steps as well as the wrought-iron and carved wood doors. The marble treads are showing significant wear due to use and exposure.
Preliminary Recommendations CATEGORY 2	<ul style="list-style-type: none"> The exterior doors should receive regular polyurethane treatments to preserve the wood.
Additional Investigation	Investigate the possibility of utilizing hydraulic cement to raise the first step. Investigate new hardware for the exterior doors to improve efficiency of operation.
Notes

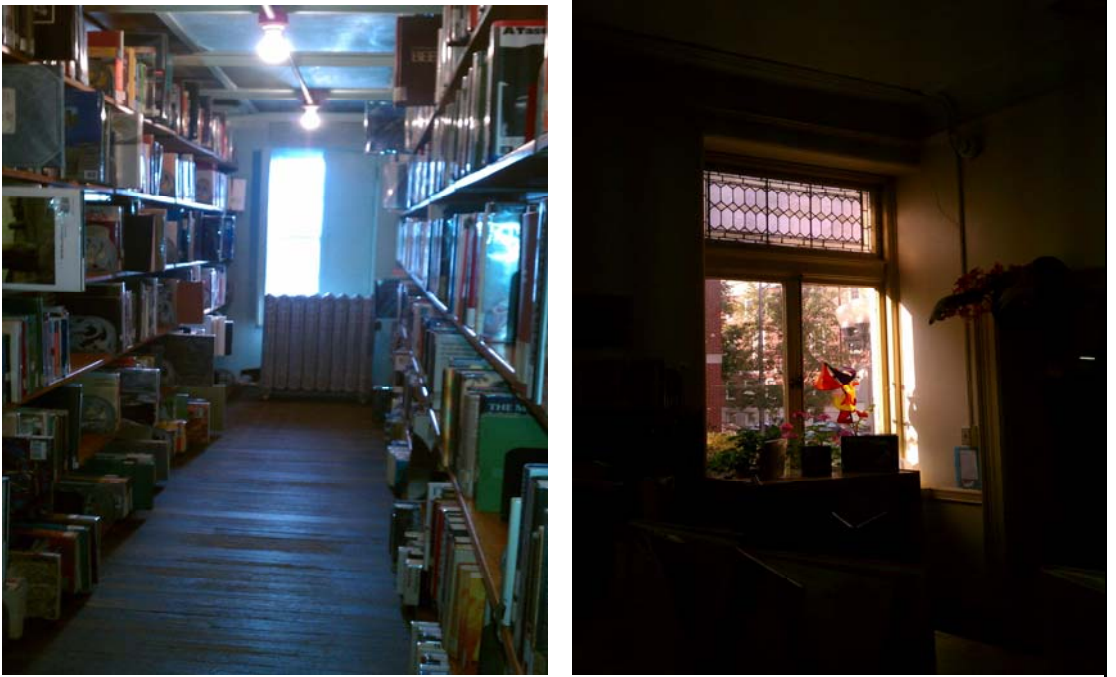
Building Element or Façade	Windows
Photo

Existing Conditions	<ul style="list-style-type: none"> Over the past few years the Library has reputedly begun a phased restoration process. Presently the upper level windows on the West façade have been restored, and the 16 paired casement windows along the main level (South, West and North facades) are scheduled to be restored as part of the annual New York State DLD Grant program.
Preliminary Recommendations CATEGORY 2	<ul style="list-style-type: none"> Provide interior storms (per the Department of the Interior's Standards for Historic Preservation) for the remaining windows in the Stacks portion of the building, as well as the large units at the Upper Level Loggia.
Additional Investigation	
Notes	Consider installing interior storms at restored windows for greater thermal efficiency.

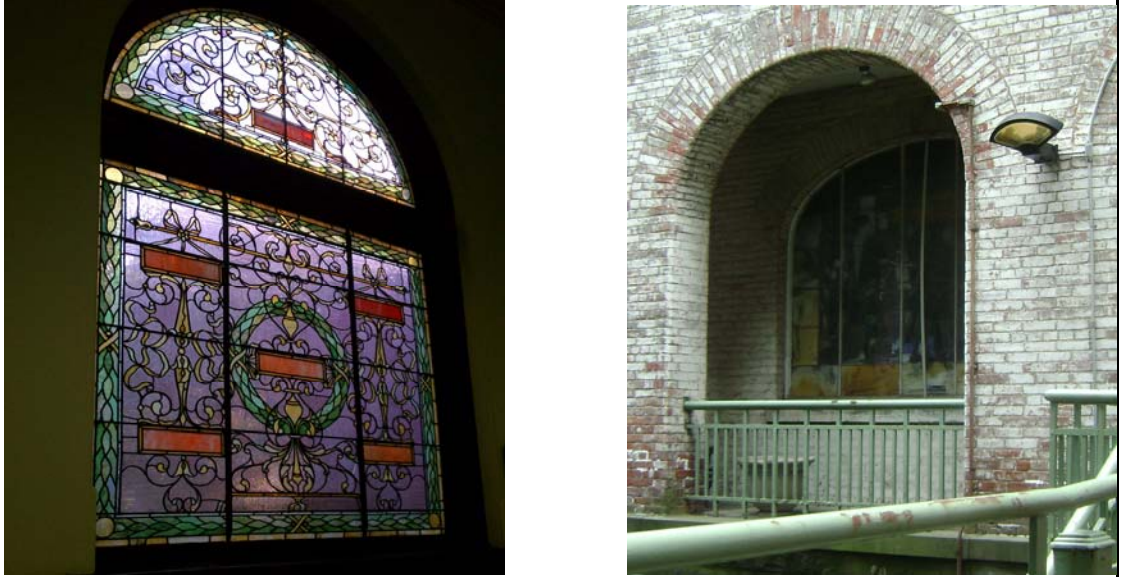
Building Element or Façade	Stained Glass Windows
Photo

Existing Conditions	<ul style="list-style-type: none"> • The Library features stained glass windows in many shapes and sizes throughout the building. There are stained glass transom units at all the windows on the Main Level North, South and West facades, some of which have been removed for the installation of residential style air-conditioning units. There are three exterior stained glass window units located at the north side of the Upper Level Reading Room, and three identical units located at the (interior) south wall of the Reading Room. On the Main Level there is a large stained glass scene crafted by Frederick Wilson on the Main Level at the Circulation Desk. And finally, there are four elaborate stained glass laylights which correspond to the building's large skylights. • Due to the size and locations of most of the units, a detailed review was not feasible from floor level, or roof. Minor repairs are evident on the wood sills, jambs and etc of the vertical units, and exterior storms have been installed at the four masonry openings on the North face of the building. These exterior storms have helped to protect the windows, but now prevent the pivoting operation of the three exterior • The three arch-topped transom units in the Reading Room are bowing and appear to be taking a convex shape (curving into the Reading Room). The horizontal green leaf component of the main stained glass panel is showing movement in a concave direction.

Preliminary Recommendations CATEGORY 2	<ul style="list-style-type: none"> • An expert in stained glass windows should be consulted to review the current state and required maintenance of the historic units. (A phased restoration effort to reconstruct the units could be proposed.) • A new custom exterior storm unit should be fabricated for the Wilson window to protect the historic window and increase staff comfort at the Circulation Desk. • When central air conditioning is established in the building, the removed and salvaged transom units should be restored to their original locations on the Main Level.
Additional Investigation	
Notes

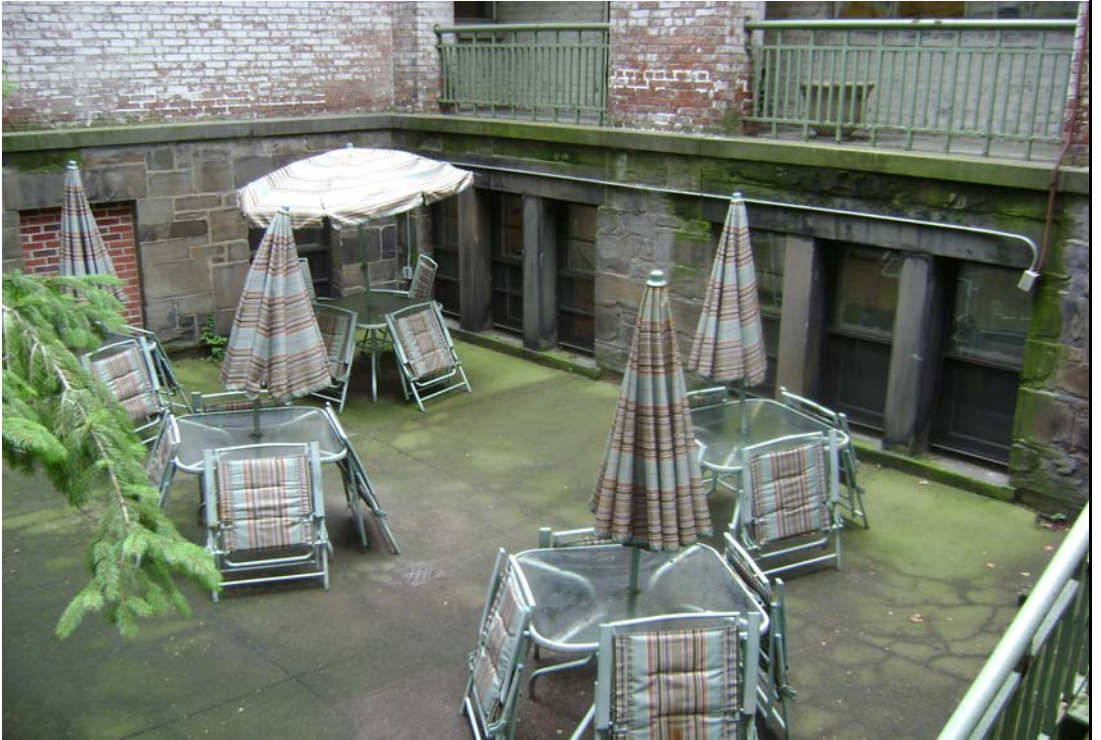
Building Element or Façade	North Courtyard
Photo

Existing Conditions	<ul style="list-style-type: none"> • Due to its enclosed northerly location, the courtyard does not experience much sun exposure and therefore suffers from excessive moisture and mold-growth. • The retaining wall at the north side of the courtyard is exhibiting failure with visibly displaced bricks. This is due to moisture infiltration into the wall cavity, as well as earth surcharge which has pushed the wall out of plumb.
Preliminary Recommendations CATEGORY 1	<ul style="list-style-type: none"> • The proposed masonry cleaning and restoration process should specifically address the mold issues in the courtyard. Following the masonry cleaning, regular maintenance (gentle power-washing) can prevent a majority of the mold. • If the retaining wall is Library property, it should be rebuilt as part of the overall masonry restoration project. If not, the Library may want to limit public access to this area of the courtyard.

Additional Investigation	Research possibility of mold-inhibiting product to be applied to historic stone and concrete surfaces.
Notes

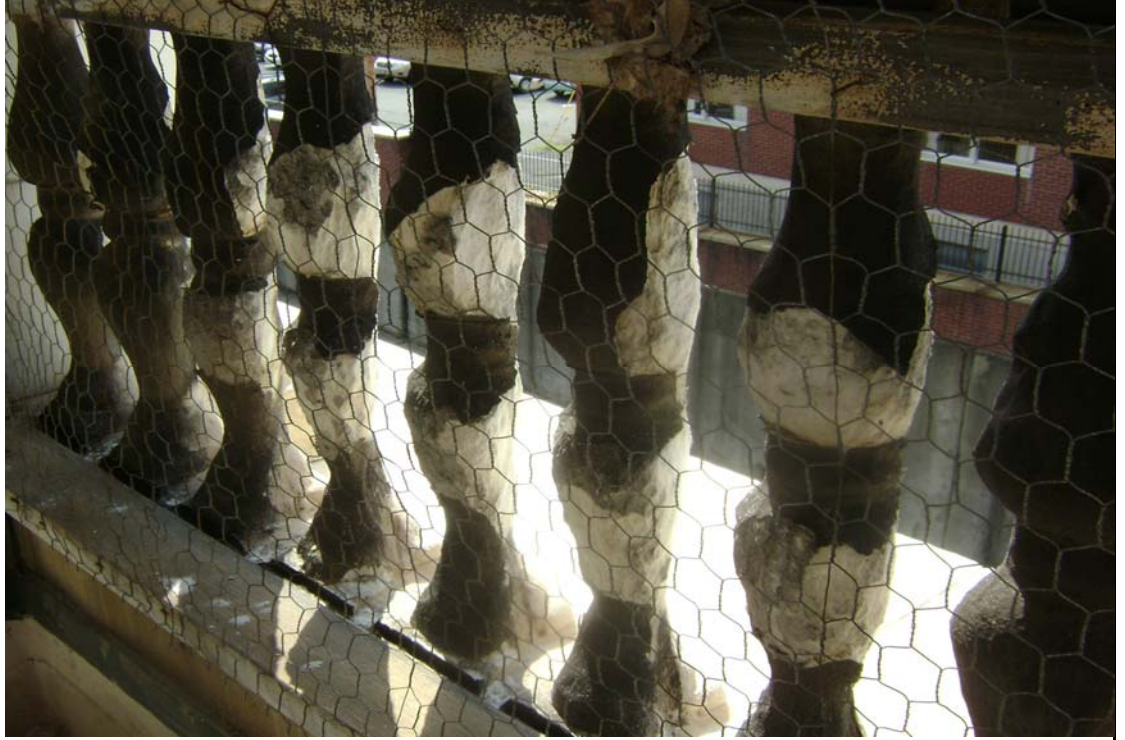
Building Element or Façade	Loggia
Photo

Existing Conditions	<ul style="list-style-type: none"> • There is advanced deterioration of the marble balustrades at the second floor loggia on the South face of the building. The excessive deterioration is largely due to the proximity to the vehicular traffic of the Ferry Street Tunnel which was constructed in the 1970's. The vehicle exhaust, combined with rain and other atmospheric contaminants, has essentially completely compromised the integrity of the marble balustrades themselves. The top and bottom rails have fared marginally better as have the columns.
Preliminary Recommendations CATEGORY 1	<ul style="list-style-type: none"> • Although there is a substantial loss of material to the balustrade units, it is recommended that they remain in place, secured with structural netting, until a comprehensive solution is identified to prevent public access to the loggia. A temporary solution would be to lock the interior doors in the Main Stair. • In addition to public access concerns, a visually non-invasive solution to prevent aviary inhabitation of this space should also be investigated.

Additional Investigation	Consideration may be given to the utilization of a fypon product for the replacement of the marble balustrades.
Notes

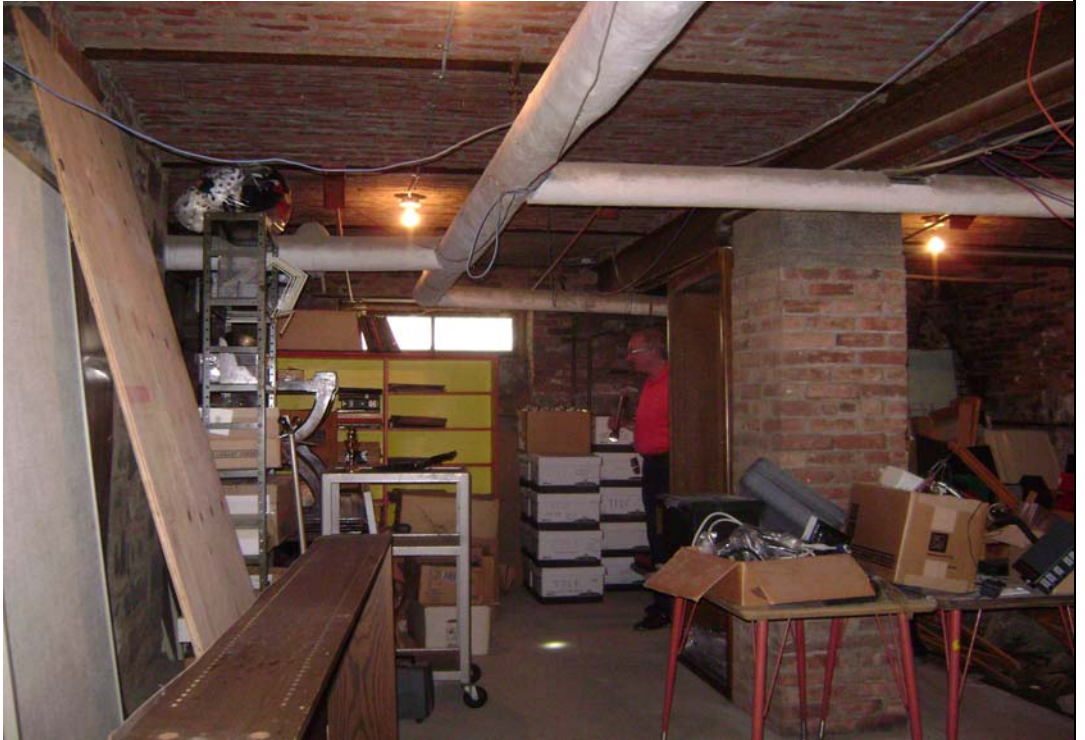
Building Element or Façade	Lower Level - Unfinished Areas
Photo

Existing Conditions	<ul style="list-style-type: none"> The west half of the lower level remains unfinished, with miscellaneous building elements, furniture, used equipment and odd items, as well as exposed piping, conduits and wiring. Full observation of this area is limited by the amount of materials present and the storage methods.
Preliminary Recommendations CATEGORY 3	<ul style="list-style-type: none"> There appears to be asbestos wrapping on many of the exposed heat pipes running throughout this area, this material should be tested and abated prior to any repairs or improvements. Any pipe abated of insulation should be re-insulated with appropriate material.
Additional Investigation	
Notes	<p>This area of the lower level has become a repository for all broken, unused or unnecessary items and materials. These items should be thoughtfully reviewed and sorted; for instance historic doors and windows from the building should be cataloged and carefully stored for potential reuse, while other more random items (i.e.: old electronics, printers, tables, shelving units, etc.) should be purged.</p>

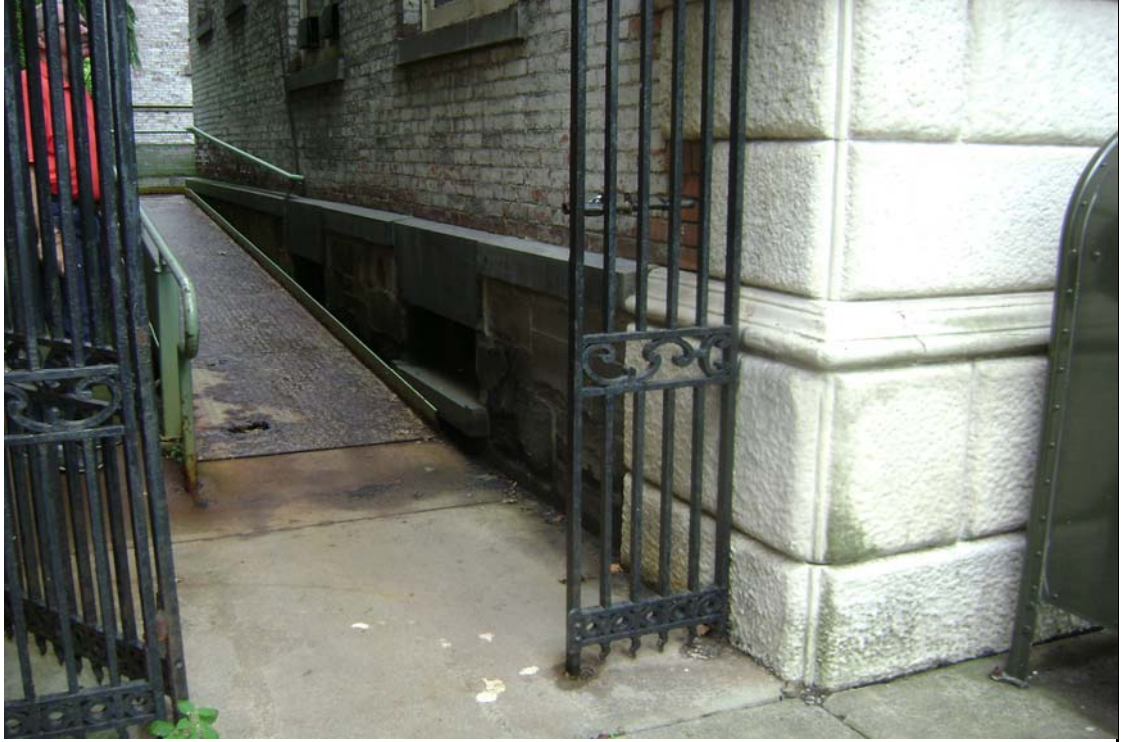
Building Element or Façade	Handicap Accessible Ramp
Photo

Existing Conditions	<ul style="list-style-type: none"> • Reputedly the existing handicap ramp is scheduled for repairs and improvements in the near future, however at the time of this report the steel supports and steel plate ramp surface are heavily rusted.
Preliminary Recommendations CATEGORY --	<ul style="list-style-type: none"> • Galvanized steel materials, painted with a high-performance epoxy base coating system with urethane top-coat, are typically recommended for this type of exterior installation and use. • General maintenance (including regular painting) should be performed to maximize the lifespan of the materials.
Additional Investigation	
Notes

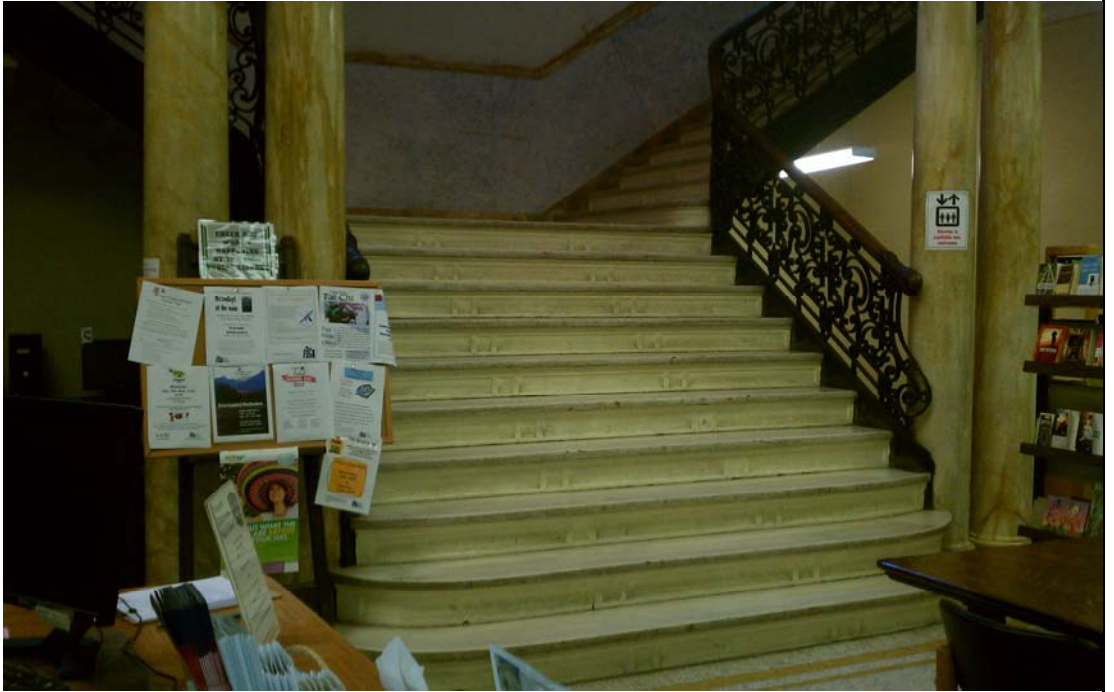
Building Element or Façade	Vertical Circulation - Main Stair
Photo

Existing Conditions	<ul style="list-style-type: none"> • The main staircase which leads from the Main Hall - Circulation and Information Desks area to the Upper Level Reading Room, Program Space and Public Access Computers. This staircase is constructed of marble treads and iron risers, it also features ornate wrought-iron handrails.
Preliminary Recommendations CATEGORY 4	<ul style="list-style-type: none"> • New paint should be applied to the iron risers to improve the overall appearance and help visually differentiate the risers and treads. • Due to the age and excessive use, the marble treads are significantly worn, care should be taken to maintain the treads and prevent slipping hazards (moisture, debris, etc).
Additional Investigation	
Notes	At this time the current handrails do not meet the standards set forth by ANSI and the ADA (Americans with Disabilities Act); it may be prudent to install an accessible handrail at the center of each run of stairs.

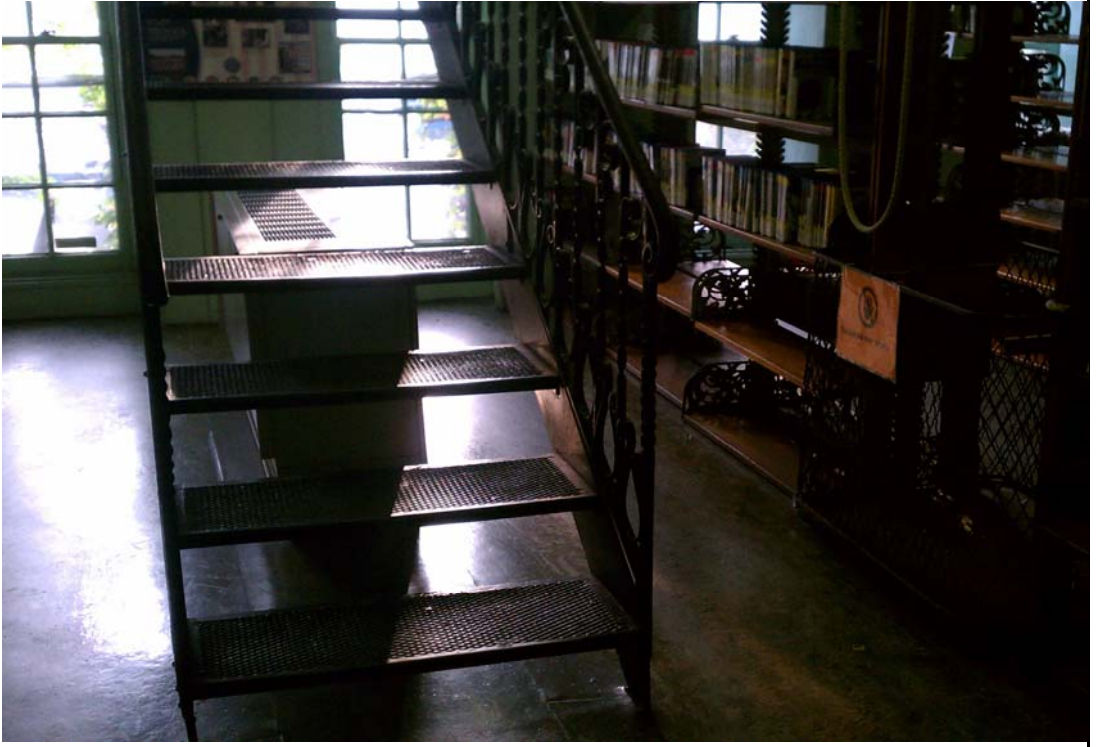
Building Element or Façade	Vertical Circulation - Stacks
Photo

Existing Conditions	<ul style="list-style-type: none"> • The rear portion of the building was constructed to house of the Library's collections on four levels of integratal stacks that feature their own wrought-iron staircase and dumbwaiter for moving materials. The main floor level of the building is approximately 6 inches higher that the corresponding floor level in the stacks, a ramp has been installed across the threshold of area, but it does not meet handicap accessibility requirements. The first and third floor levels of the collection space roughly align with the Main and Reading Room floor levels. There is an intermediate level of stacks between the main and upper levels, and the fourth level of the stacks is approximately one-half floor level above the Reading Room floor level. This fourth level is currently accessed only by staff and does not house active collections. • Although the collection space was originally intended to be accessed only by a Librarian, patrons are now free to browse the first three levels of the stacks. The construction and layout of these stacks was intended to maximize collection storage, with the end panels of the stacks serving as vertical supports for the floor above.

Preliminary Recommendations	<ul style="list-style-type: none"> • Based on the one-of-a-kind historic status of this space, and the integrated structure of the stacks, very little can be done to improve patron access and ADA compliance.
CATEGORY --	
Additional Investigation	
Notes

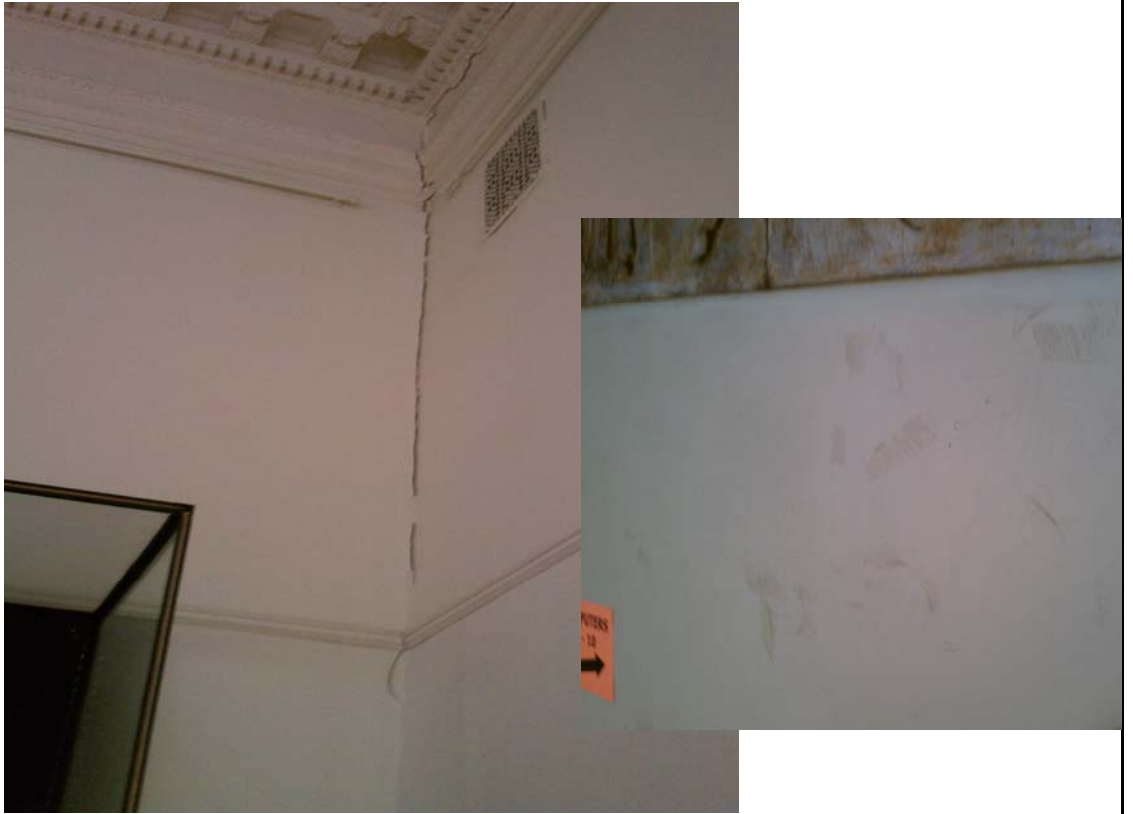
Building Element or Façade	Plaster Walls
Photo

Existing Conditions	<ul style="list-style-type: none"> • A majority of the original plaster walls appear to be in good to excellent condition. Some areas show scuffing and debris from postings, but little permanent damage is evident. The only significant areas of cracking and wall damage appear at the southwest corner of the building, which has been attributed to the construction of the 1970s Ferry Street Tunnel.
Preliminary Recommendations CATEGORY 2	<ul style="list-style-type: none"> • It appears that the building has accommodated the structural changes from the imposition of the 1970s tunnel and is no longer moving / settling, however the installation and review of vibration monitors for a few months could confirm this assessment. • Once the moisture infiltration at the roof leaders is resolved, the plaster damage in the Reading Room and Teen Space should be repaired by a qualified historic craftsman.

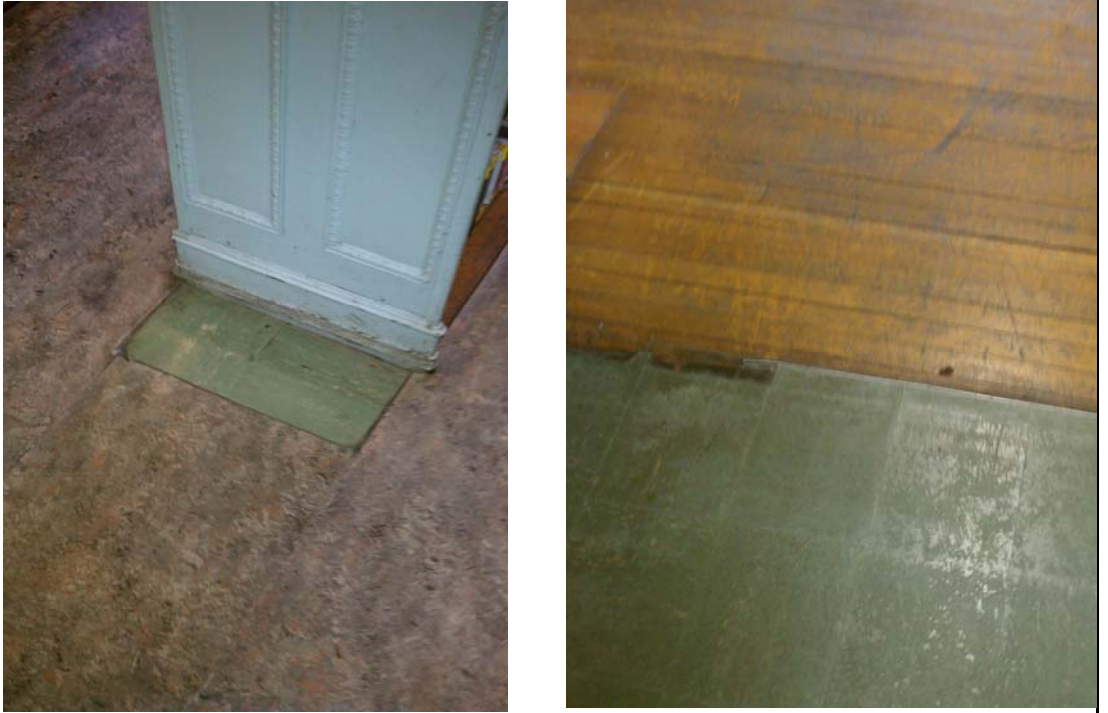
Building Element or Façade	Finished Floors
Photo

Existing Conditions	<ul style="list-style-type: none"> • The building features mosaic tile, marble, hardwood, linoleum, carpet and composite tile floors, of various ages and levels of wear throughout the building. • The mosaic tile floors are in the best condition and should remain so if proper care is maintained. • The marble floor and treads of the main staircase are in good condition, but have been worn down by over a hundred years of foot traffic. The hardwood floors featured in the Teen Room, Public Access Computer Room, Program / Museum Spaces and etc also show significant wear and deterioration from heavy usage. The large Reading Room features a composite tile which is assumed to be asbestos based on the color and size of the tiles. • The four levels of stacks feature multiple floor finishes, some in layers. The original glass and steel floor construction, is visible on some levels, but other areas have hardwood flooring or linoleum installed, and in one area there is the linoleum product installed over composite tile.

Preliminary Recommendations CATEGORY 3	<ul style="list-style-type: none"> • Prior to the implementation of any floor finish replacements, or significant interior improvements, hazardous material testing should be performed on the non-original floor finishes (linoleum sheet product, composite tile, etc).
Additional Investigation	
Notes
